Rail Delivery Group

RDG Guidance Note: Selection and Assurance of Fasteners for Legacy Fleets

RDG-ENG-GN-007
Issue 1 – April 2019

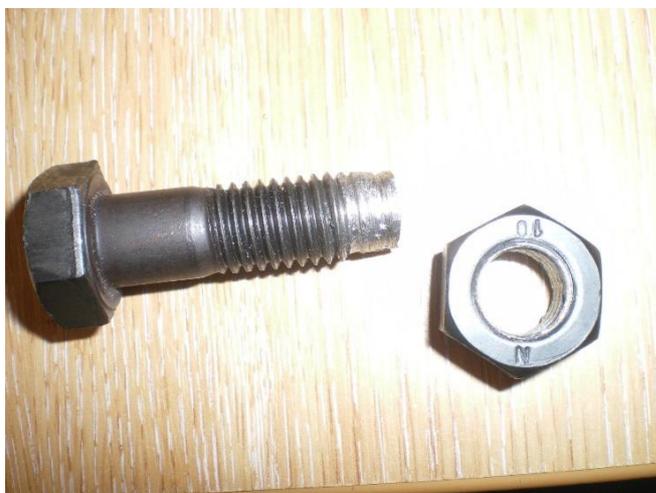
Initial findings identified the suspect bolts to have been marked 'BCSF'. Testing was undertaken on fasteners supplied by an alternative source giving satisfactory results, indicating the problem lied with 'BCSF' stamped bolts.

Similar tests were carried out on the M16 fasteners with the same results observed.

Bolts also displayed variable locking properties. When testing a batch of fasteners, it was possible to run the locking nut significantly past the end of the bolt. This occurred on two bolts. The nut was then tried on other bolts and it displayed locking properties indicating that the issue was with the bolt formation.

Analysis & Findings	<p>Bolts with head stamping 'BCSF' were found to exhibit the thread stripping and nut removal concerns (other head markings were found not to be affected).</p> <p>The independent investigation identified that bolts stamped with 'BCSF' had a different thread form. On tightening, the inconsistent thread form of the 'BCSF' bolts meant they would not freely engage with the thread of the nuts and would</p>
--------------------------------	--

Scope	All BCSF M14 and M16 bolts were quarantined to prevent further supply. An investigation was undertaken by Unipart Rail Ltd [URL], involving their supplier and independent industry experts.
--------------	--

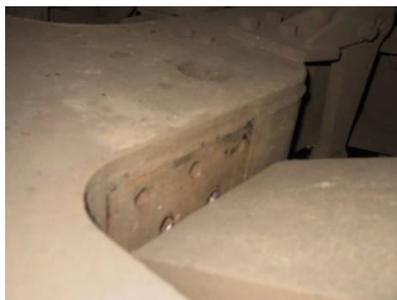
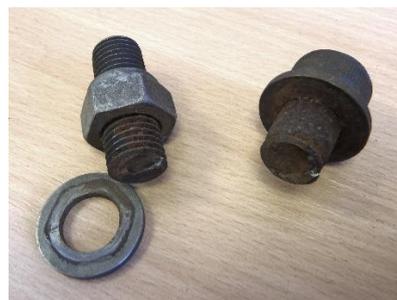
The original tapping plate arrangement was augmented by the use of 'Tappex' inserts to counter the effects of wear. A through bolted arrangement is now the preferred solution and many bogies have been modified to this arrangement. Maintenance arrangements have been implemented over the years as a result of lessons learned.

- A lack of surface flatness between the mounting face of the bracket and the bogie transom mating area can be a cause of failure. Specification CR/TP1118 incorporates a combined surface flatness

tolerance of 0.25mm. Surface flatness can be affected by corrosion in this area.

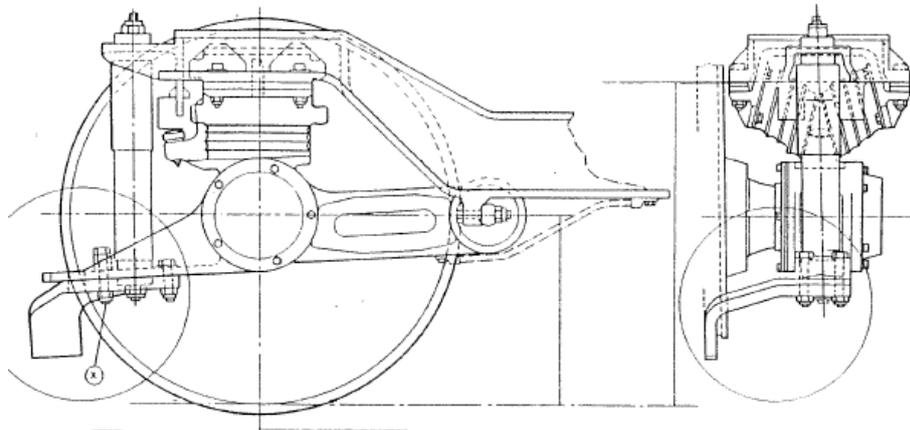
To meet the lifeguard impact load specification for the Class 150 type, a newer type of fixing, comprising four 20 mm diameter bolts secured by 'bent beam', Philidas nuts, was adopted. Although a 'bent beam' nut requires additional torque to move on the thread, the important factor is the design pre-load. The design drawing for the Class 150 bogies specified 476 Nm, for which a 3 ft (1m) torque wrench would be required, equipment that was, at the time, not normally carried by artisan staff but available for use at main depots.

If the nuts are disturbed for any reason and not subsequently re-torqued to the correct figure, Philidas nuts may become loose through vibration in service.

All rolling stock fitted with lifeguards secured by self-locking nuts shall be subject to a common practice of replacement of both nuts and bolts on detection of looseness. (BR had already committed to this practice on account of its own investigations in the aftermath of the accident).

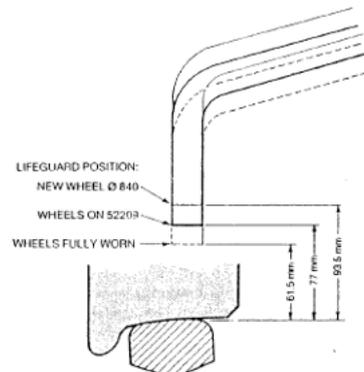
- a) The two inner bolts of the left-hand leading lifeguard on vehicle No 52209 were missing and had probably been missing for several hundred miles before the derailment occurred.

- b) The outer two bolts on the lifeguard were in position but were loose at the time of the derailment. Both of these bolts had probably been loose for several hundred miles before the derailment.

- c) The lifeguard was loose enough to be hanging down towards the rail, at an angle of about 8°.
- d) The amount by which the lifeguard was loose was possibly enough to reduce the nominal clearance to rail track from 77 mm to 27 mm.

- e) The loosely hanging lifeguard on vehicle No. 52209 struck a substantial concrete block (and possibly other pieces of concrete) at a speed of about 45 mph some one and a half miles before St Helens Central Station on the evening of 11 November 1988.

- f) The impact of the lifeguard on the block would have been sufficient to bend the bolts, elongate the holes in

the lifeguard, further reducing the clearance to the rail head.

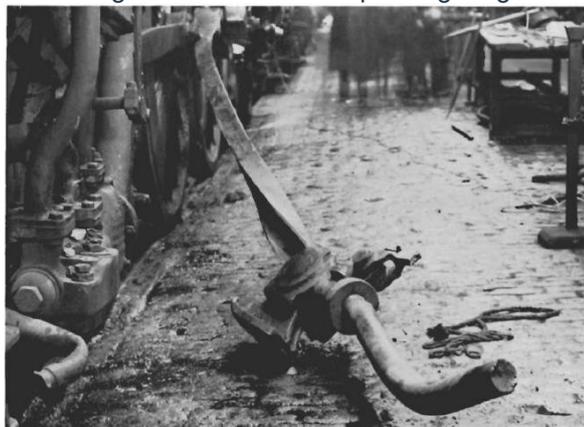
Examination of the locomotive showed that the two bottom right hand slide bars had fallen off, causing the motion parts to become detached.

Photograph 1. The Britannia locomotive showing the displaced motion assembly.

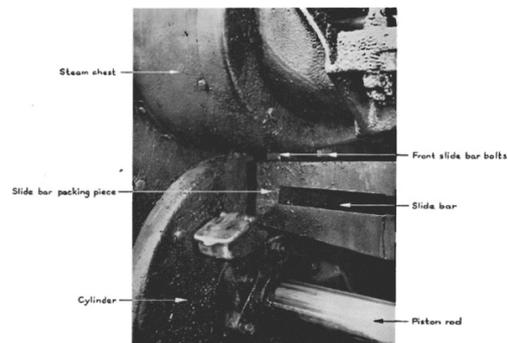
The bolts had been reported as loose (and tightened up) at nine separate inspections in between its last overhaul and the day of the accident.

The investigation into the accident identified that the design of the front fixings of the slide bars made it difficult to tighten the nuts at the top of the bolt assembly, including the insertion of the split pin, due to the presence of the adjacent steam chest cover.

Photograph 3. Front end of slide bar assembly before modification
